AIRCRAFT RESEARCH REPORT

Local Flow Control III

This report presents CAFE flight test results on wing root flow guides as a modification to the Globe Swift.

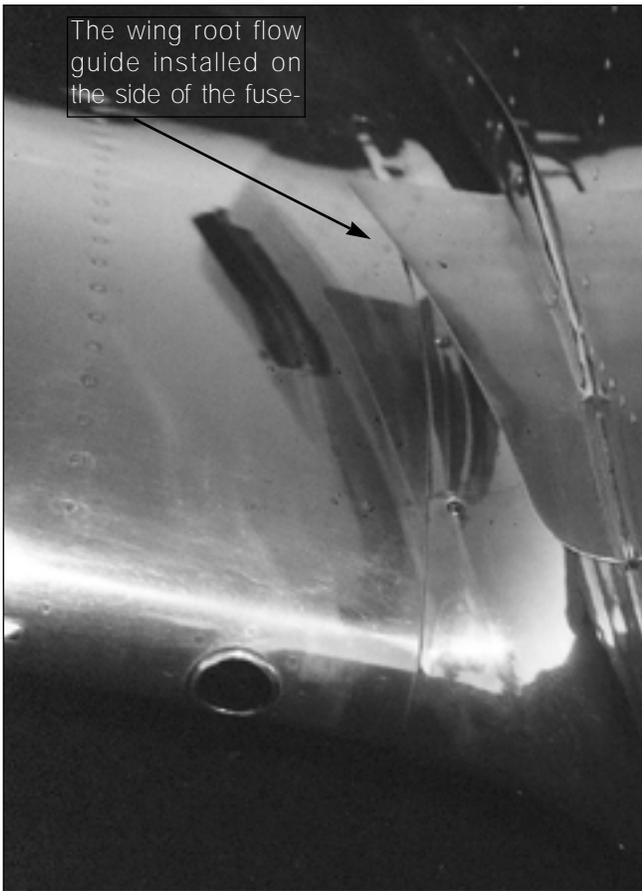
The wing root flow guide installed on the side of the fuse-

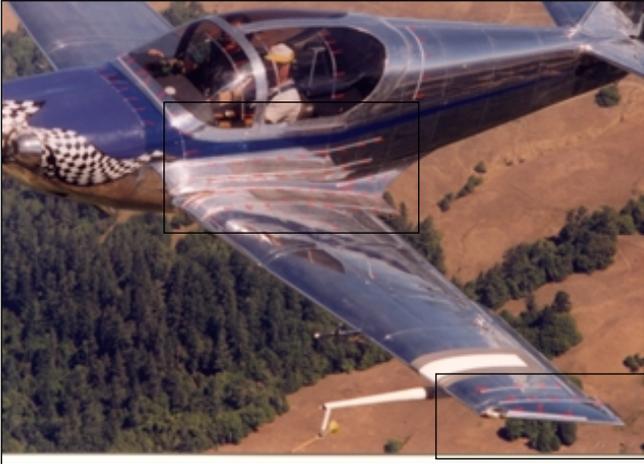
or reversal. The left aileron is deflected downward, increasing the angle of attack of that left wingtip. The tufts along the top of the outer edge of the sheared wingtip are kicked up high due to the wingtip vortex that spirals out from under the wing. The large downward angle of the Barograph's brass pitot static probe shows the high angle of attack at stall. The tufts on the side of the fuselage graphically emphasize the influence of the top of the wing on local flow direction.

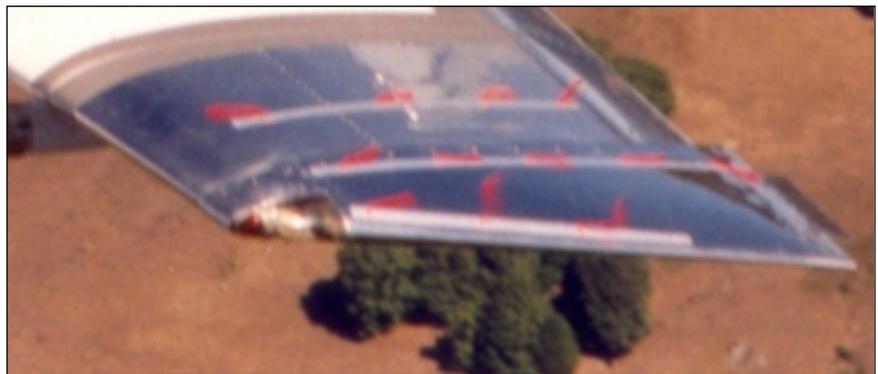
Looking closely, we can see that the row of red yarn tufts about 12" outboard of the wing root flow guide are showing the chaotic flow reversal typical of the stalled condition. They are disoriented and pulled into distorted shapes as far forward the 20% of chord location. However, the tufts directly aft of the flow guide are still lying down fairly flat back to about 65% of chord, where one tuft is seen to be standing up off the surface.

The wingtip VG had been removed in this stall photo. The 3 wingtip tufts at 20% of chord and the tuft just forward of the aileron hinge point are all showing separation
